Patterns and mechanisms of repeat drainages of glacier-dammed Dañ Zhùr (Donjek) Lake, Yukon

Moya Painter^a, Luke Copland^b, Christine Dow^b, Will Kochtitzky^{b,a,c}, and Dorota Medrzycka^b

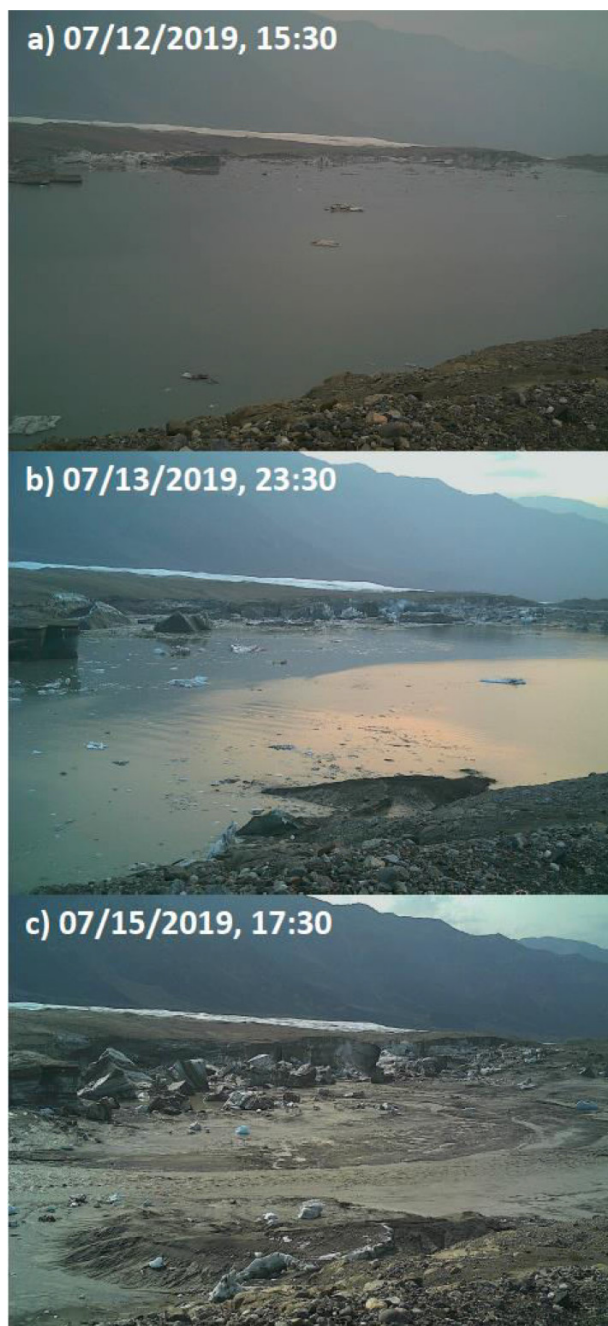
Fig. 4. Images from the timelapse camera (see viewed in Fig. 1) showing before, during, and after 2019 lake drainage: (a) July 12, 15:30; (b) July 13, 23:30; and (c) July 15, 17:30. All times are in local Pacific Standard Time (PST) (GMT-8). For scale, it is approximately 1 km from the camera to the edge of the glacier.

We also captured the 2019 drainage event using a SpyPoint solar trail camera, which was installed on 12 July 2019 on a small tripod securely mounted on bedrock, and recorded images hourly. The camera overlooked the lake and terminus of Dañ Zhùr Glacier (Figs. 1 and 4), including the location where the lake drained.

The timelapse camera and pressure transducer provide a detailed timeline of lake levels during the 2019 lake drainage event (Figs. 4 and 5). These instruments show that drainage started at 17:30 PST on 12 July 2019 and continued until about noon on 15 July 2019.

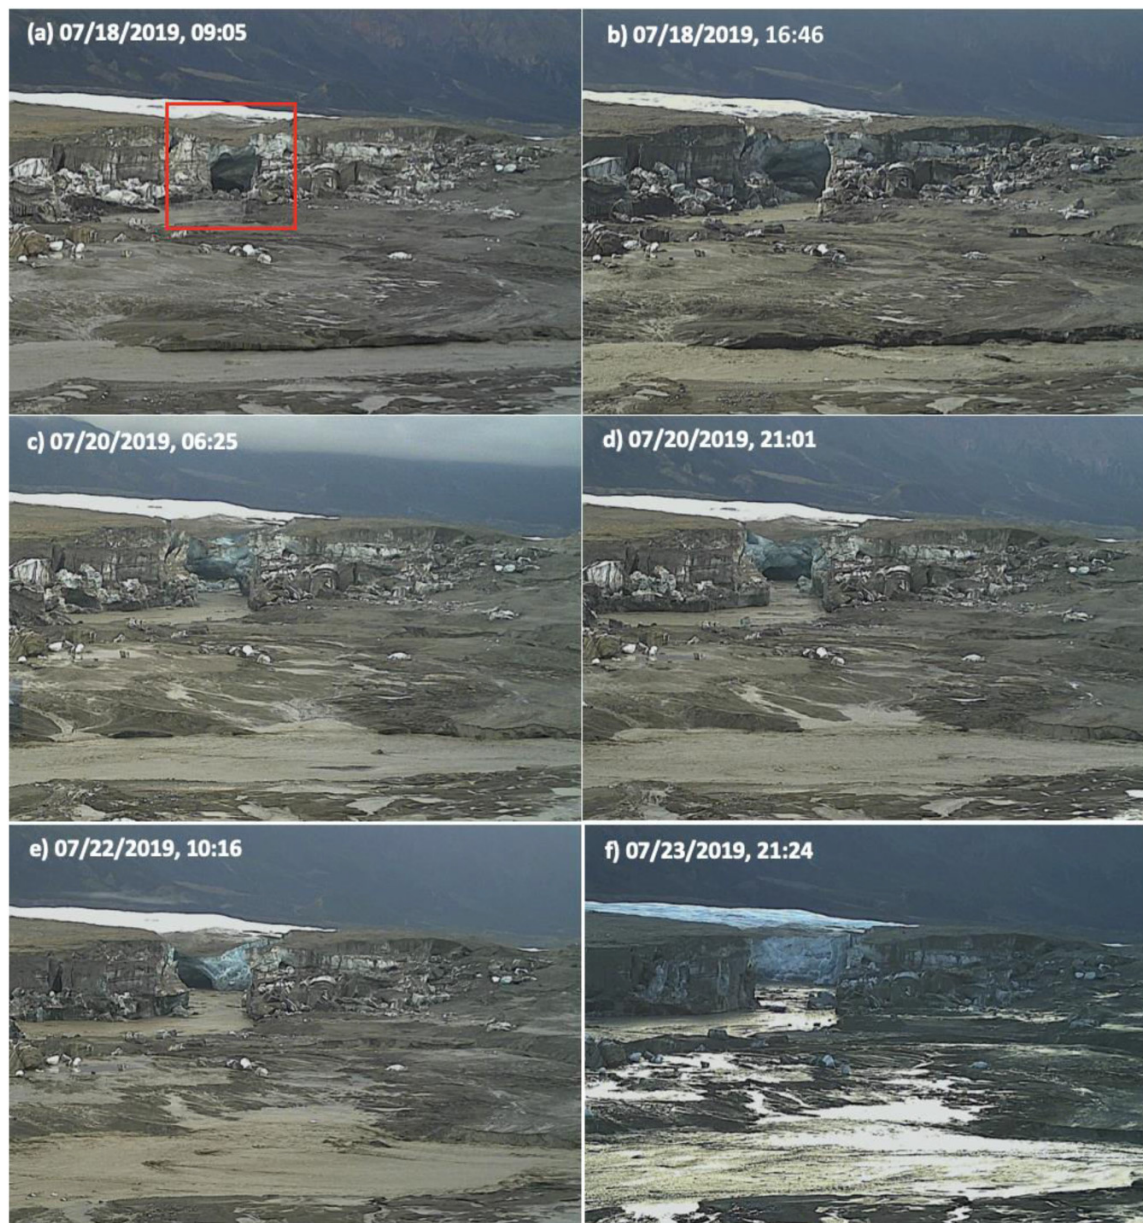
Fig. 7. Timelapse camera photos of the development of the ice canyon at the terminus after the 2019 drainage event. Red box indicates canyon location. All times are local PST (GMT-8).

Satellite imagery and the timelapse camera show that on 16 July 2019, the roof of the new channel was still present. On 18 July, some subsidence and collapse of the roof occurred near the channel entrance (Figs. 7a and 7b), as indicated by expanding crevasses on either side. The canyon continued to grow over the following days (Figs. 7c, 7d, and 7e), until the roof completely collapsed on 23 July (Fig. 7f).
